Manhole Inspection Summary

Manhole # S13E__007MH

Insp Date: **2/7/08 9:17 AM**

Location Address: **2867 MULBERRY ST**

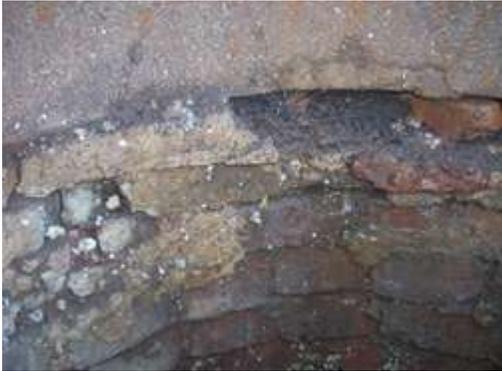
Defect 5

Infiltration: None Joint Cracks Mortar Roots **Wall**

INFILTRATION OF THE CORBEL WALL

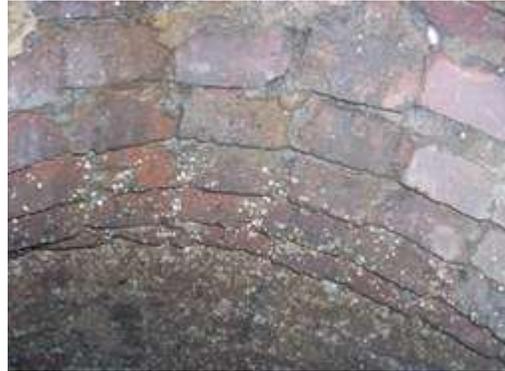
Defect 4

Surcharge **Evidence Of Surcharge** Depth: **5** (ft.) Active Surcharge Present

SURCHARGE EVIDENCE ON THE WALLS

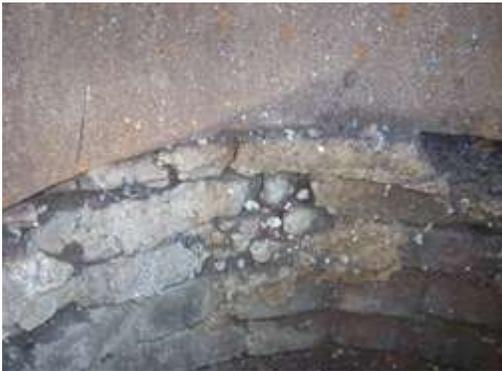
Defect 3

Condition: Sound Cracked Root Intrusion **Loose Brick** **Deteriorated**

DETERIORATED CORBEL

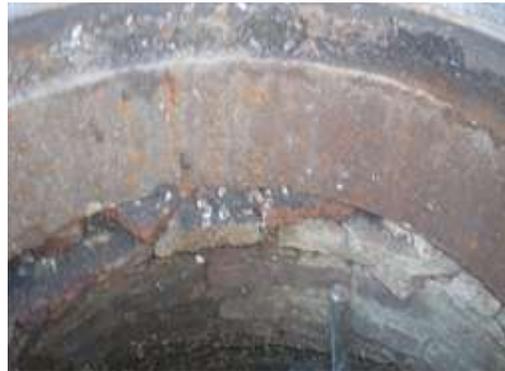
Defect 2

LOOSE CORBEL BRICKS

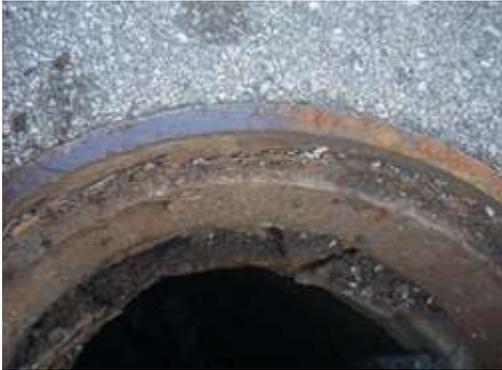
Defect 1

Frame Offset: **3** (in.) Condition: Sound Cracked Leaks

FRAME OFFSET

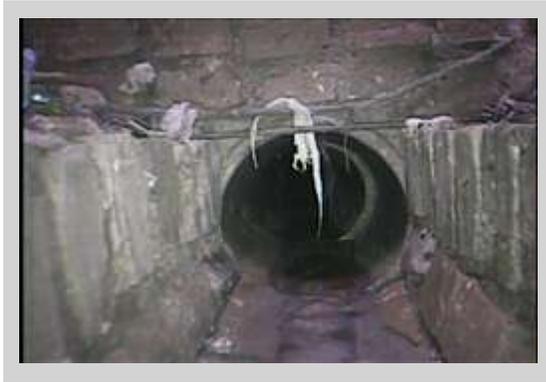
12 O'Clock Outflow

8 in. Circular Gravity Sewer
Pipe Out @ 12 O'Clock

Pipe Height: **8.4** (in.) Rod and Bar (Angled)
Pipe Material: **Clay** Pipe Lined
Invert Depth: **6.73** (ft.) Flow Characteristics: **Slow**
Deposits: None Mud Sludge Debris Grease
Silt Depth: (in.) Deposits Extent:
Infiltration: **None** Pipe Seal Cond: **Sound**

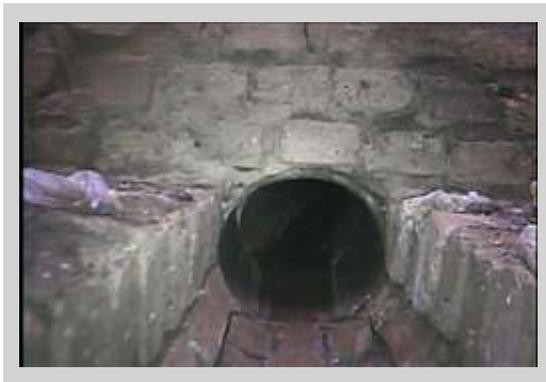
6 O'Clock Inflow

8 in. Circular Gravity Sewer
Pipe In @ 6 O'Clock

Pipe Height: **8.4** (in.) Rod and Bar (Angled)
Pipe Material: **Clay** Pipe Lined
Invert Depth: **6.63** (ft.) Flow Characteristics: **Slow**
Deposits: None Mud Sludge Debris Grease
Silt Depth: (in.) Deposits Extent:
Infiltration: **None** Pipe Seal Cond: **Sound**
